RE: Block House Municipal Utility District -
January 17, 2024 Special Meeting

BLOCK HOUSE MUNICIPAL UTILITY DISTRICT

2-5 play system

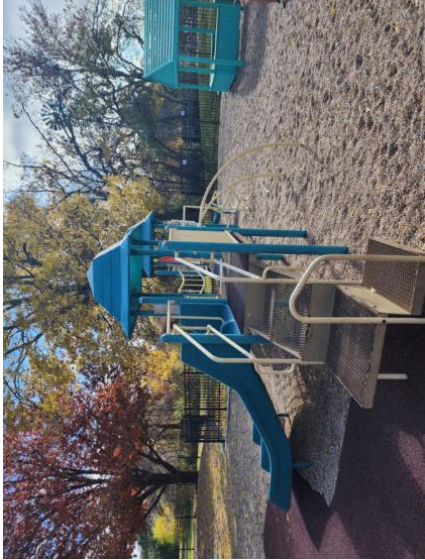
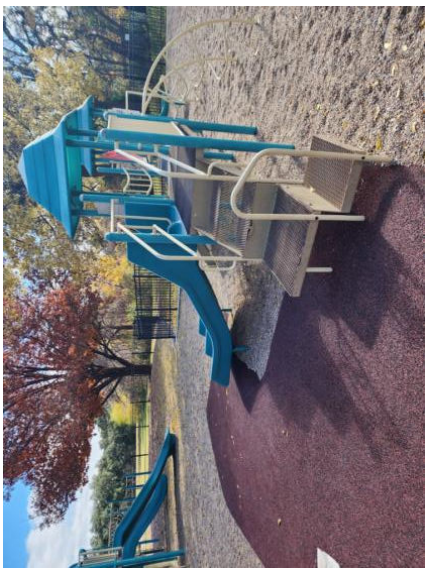
1 (1)

The system has expanded metal, welded to steel frames. Common design from this era.

Common problem is rusting, delamination, broken metal, peeling of coating, sharp edges. The metal has a limited life due to thickness and the number of welds.

The current system heavily rusting, the deck shows signs of metal fatigue, delamination of coating as well as the frame are separating. They are a laminated-layered design,

Fail

All decks and stairs must be replaced.
Possible welding could be done.

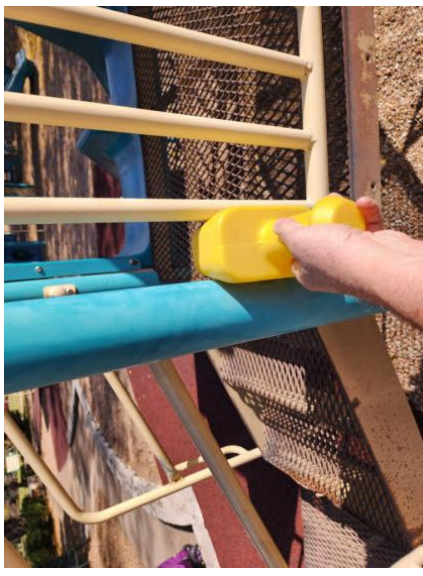
1 (8)

Head and neck entrapment testing.
The tool represents the body size of the smallest user. If the device can penetrate the opening, the condition is a head and neck entrapment that can cause Strangulation

Pass

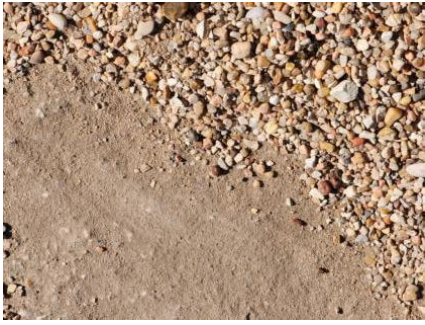
1 (21)

There is not safety surfacing around the play structure. The years of the pea gravel exposed to rain, wind, dust, dirt, has created a hard surface. The entire area of the use zone will need to be removed and a new surfacing added. Pea gravel has only been tested for a fall height of 60". Is not accessible for users with disabilities.

Deficiency

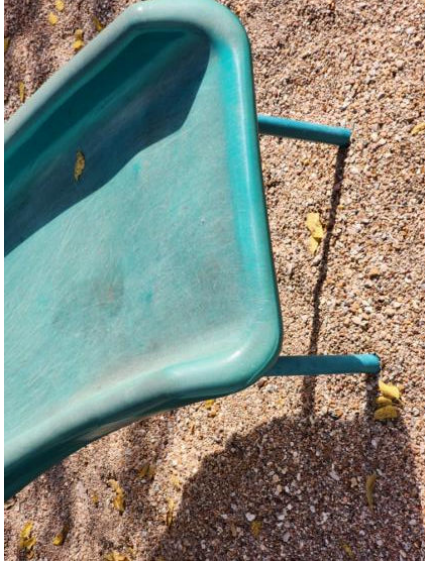
1 (23)

8.5.5.3 For slides with an elevation of no greater than 48 in. (1220 mm), the height of the exit end of the sliding surface shall be no greater than 11 in. (280 mm) above the protective surfacing. For slides with an elevation greater than 48 in. (1220 mm), the height of the exit end of the sliding surface shall be between 7 in. (180 mm) and 15 in. (380 mm) above the protective surfacing

Fail

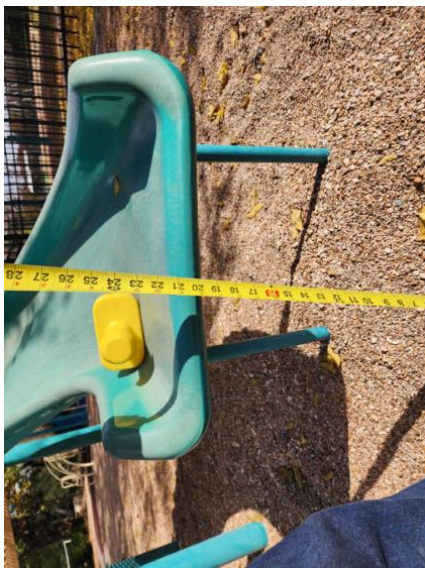
1 (24)

The slide has cracks. The support is starting to protrude. Replacement is needed.

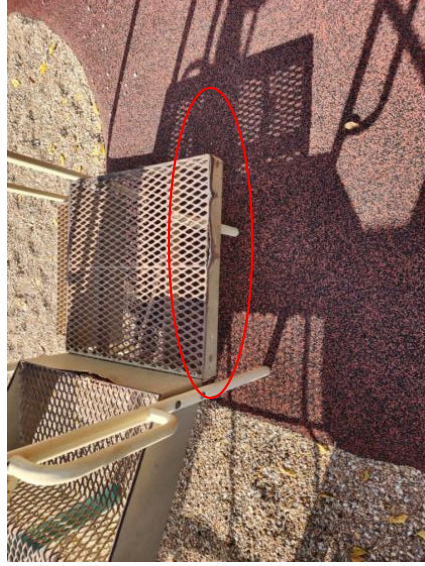
1 (40)

Heavy rusting and delamination.

Deficiency

Replace

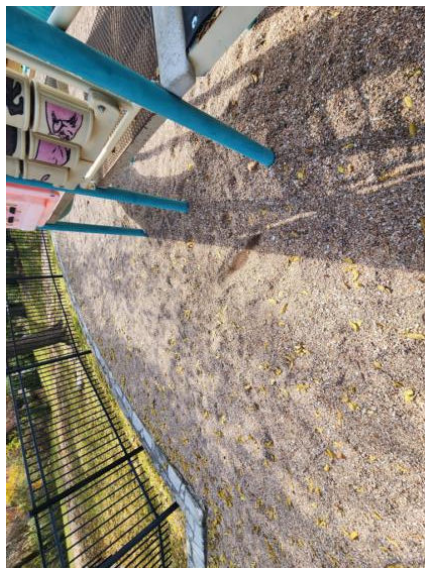
1 (44)

The play area is covered with pea gravel as a safety surfacing, however the current depth of the gravel offers no fall protection.

There is not safety surfacing around the play structure. The years of the pea gravel exposed to rain, wind, dust, dirt, has created a hard surface. The entire area of the use zone will need to be removed and a new surfacing added. Pea gravel has only been tested for a fall height of 60". Is not accessible for users with disabilities.

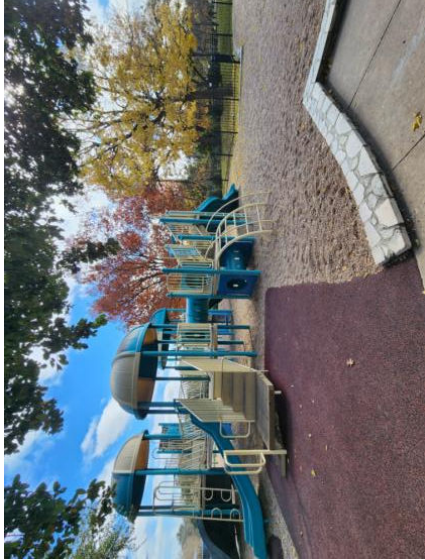
1 (46)

No deficiency found on the climbing components

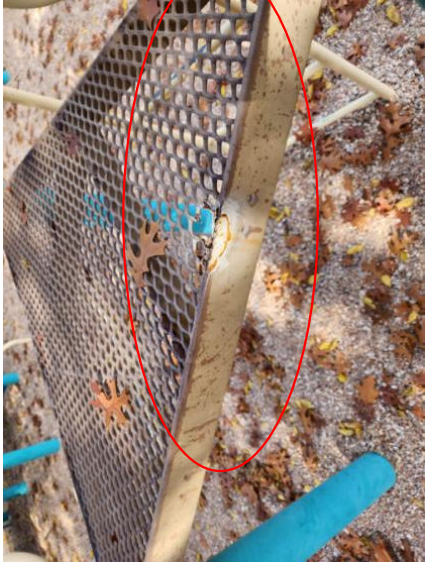
1 (63)

The expanded metal has rusted through.
Repair or replace platform.

Deficiency

Suggest re coating platforms and stairs. The rust may not be presenting structural deficiencies. If that route is done, verify.

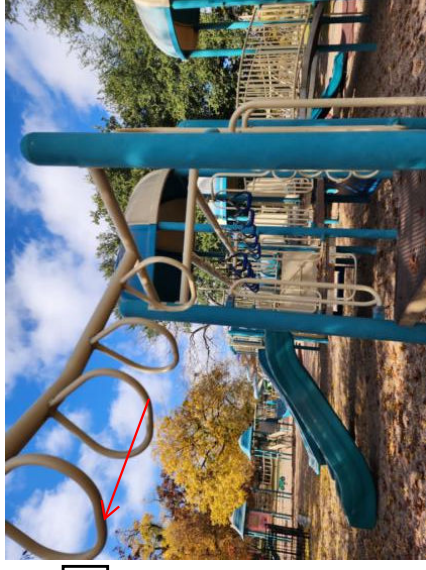
1 (65)

The "S" hook needs to be closed.

Fail

FAIL
Lower Loop gap
>0.04 in. (1.0 mm)

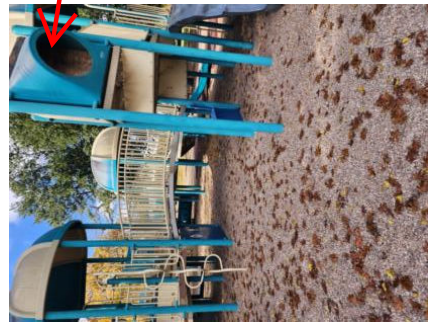
1 (82)

Fail

Replace with
commercial barrier
panel

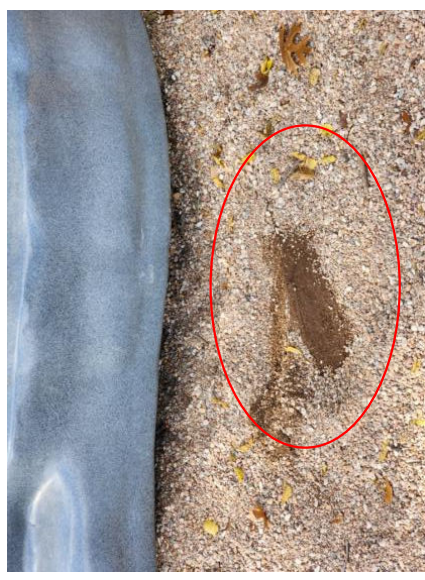
1 (87)

The dark area represents the earth beneath the surfacing.

Fail

There is not safety surfacing around the play structure. The years of the pea gravel exposed to rain, wind, dust, dirt, has created a hard surface. The entire area of the use zone will need to be removed and a new surfacing added. Pea gravel has only been tested for a fall height of 60". Is not accessible for users with disabilities.

Commercial barrier panel is
needed.

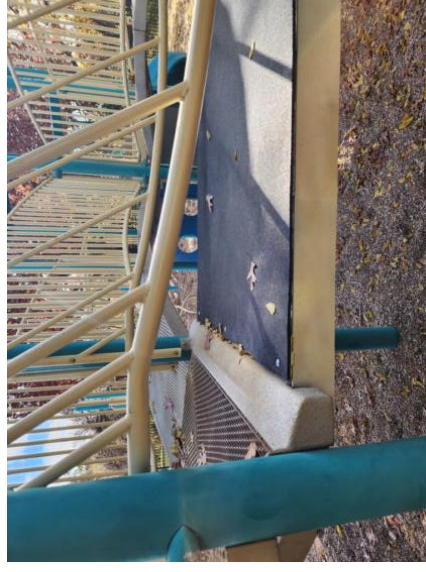
1 (91)

This rigid deck replaced the flexible bridge that was witnessed during the 2022 inspection. The replacement has created head and neck entrapment. Rigid bridge, horizontal bridge of this design do not have curved safety barriers,

Fail

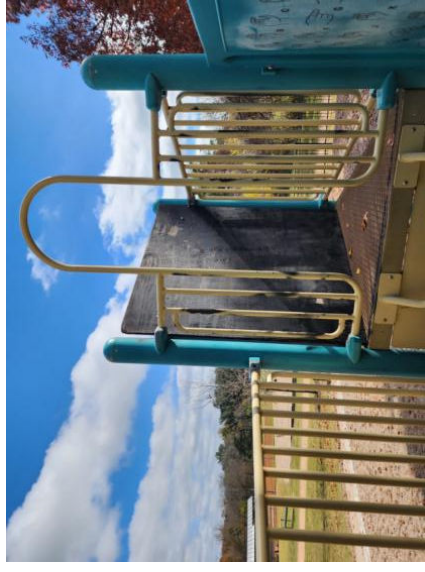
1 (113)

The slide has been replaced with a wood barrier panel. Mixing of material is discouraged. A commercial barrier panel should replace this. Children must be visible when using the play system.

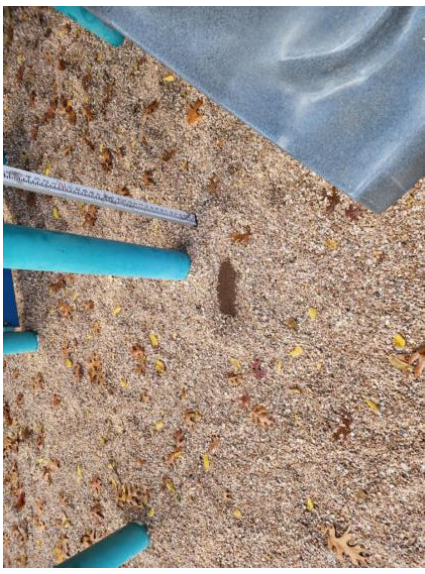
1 (115)

The dark area represents the earth beneath the surfacing.

Fail

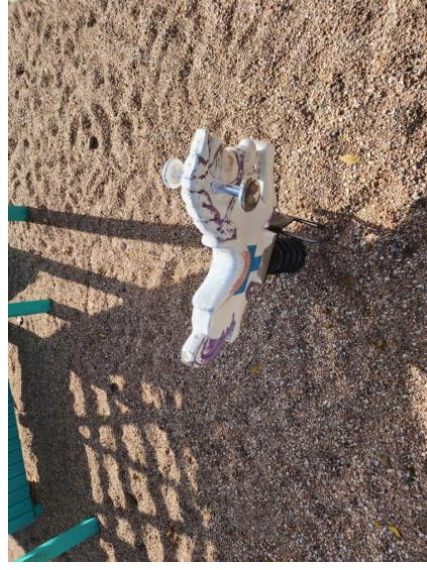
1 (145)

Peeling paint, splinters developing

FAIL
