RE: Block House Municipal Utility District -
January 17, 2024 Special Meeting

BLOCK HOUSE MUNICIPAL UTILITY DISTRICT

2-5 play system

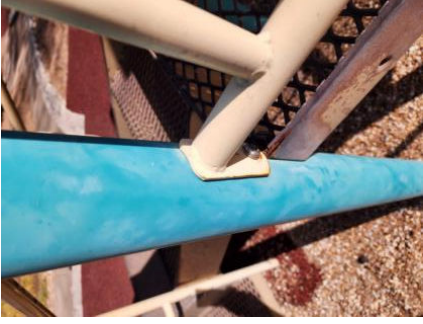
1 (9)

Head and neck entrapment testing.
The tool represents the body size of the smallest user. If the device can penetrate the opening, the condition is a head and neck entrapment that can cause Strangulation

Pass

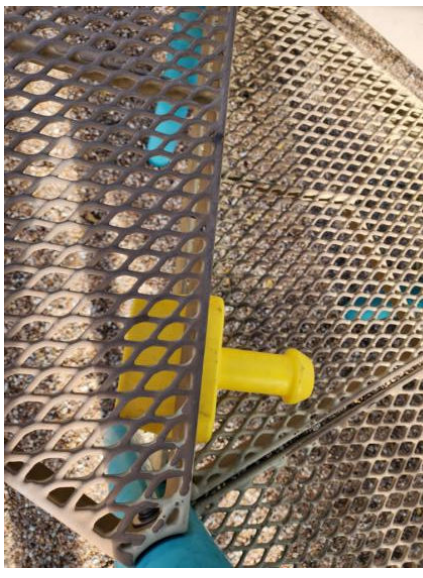
1 (12)

Pass

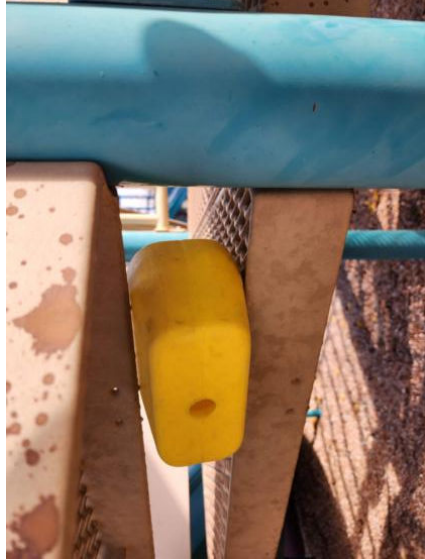
1 (13)

Pass

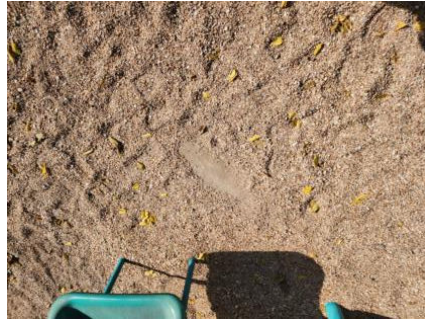
1 (20)

There is not safety surfacing around the play structure. The years of the pea gravel exposed to rain, wind, dust, dirt, has created a hard surface. The entire area of the use zone will need to be removed and a new surfacing added. Pea gravel has only been tested for a fall height of 60". Is not accessible for users with disabilities.

Deficiency

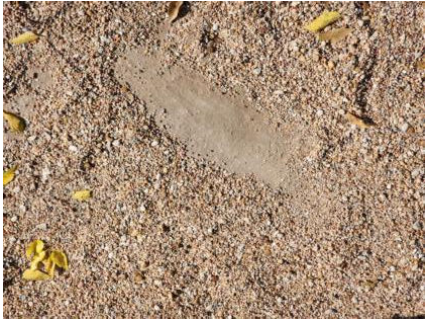
1 (22)

8.5.5.3 For slides with an elevation of no greater than 48 in. (1220 mm), the height of the exit end of the sliding surface shall be no greater than 11 in. (280 mm) above the protective surfacing. For slides with an elevation greater than 48 in. (1220 mm), the height of the exit end of the sliding surface shall be between 7 in. (180 mm) and 15 in. (380 mm) above the protective surfacing

Fail

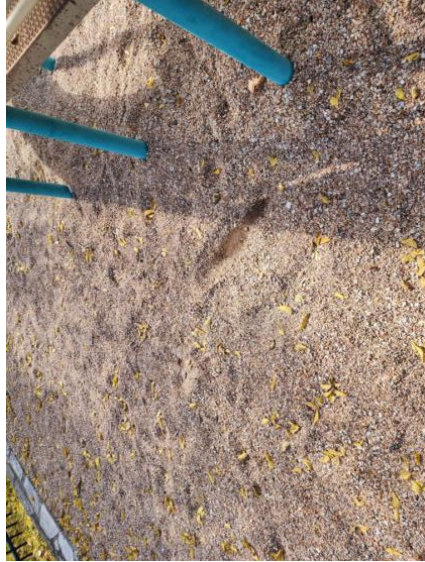
1 (43)

Age group for this play system: 5-12 years

The play area is covered with pea gravel as a safety surfacing, however the current depth of the gravel offers no fall protection.

There is not safety surfacing around the play structure. The years of the pea gravel exposed to rain, wind, dust, dirt, has created a hard surface. The entire area of the use zone will need to be removed and a new surfacing added. Pea gravel has only been tested for a fall height of 60". Is not accessible for users with disabilities.

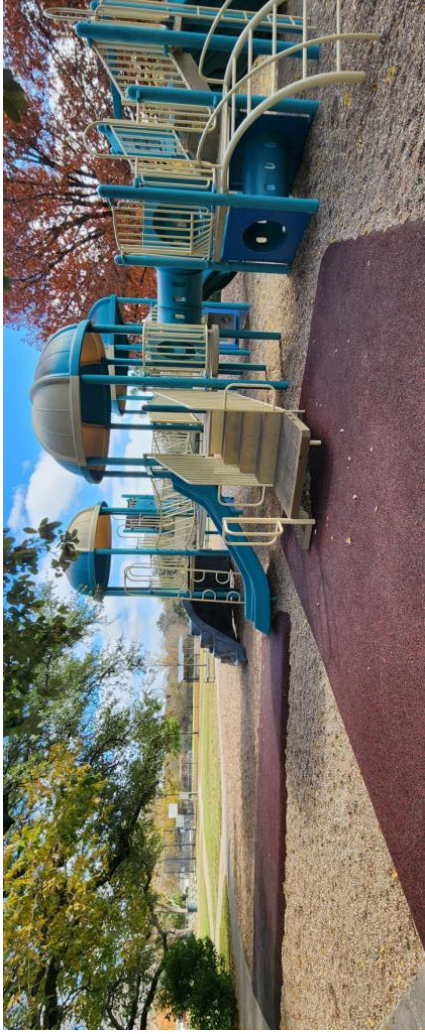
1 (45)

No deficiency found on the climbing components

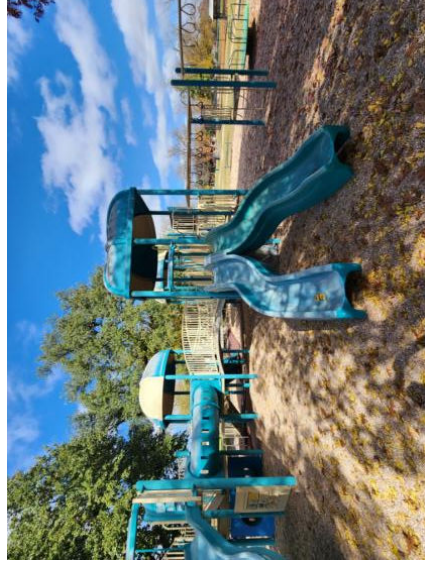
1 (51)

5.3. Chute exit region
 All slides should have an exit region to help children maintain their balance and facilitate a smooth transition from sitting to standing when exiting. The chute exit region should:
 • Be between 0 and -4° as measured from a plane parallel to the ground.
 • Have edges that are rounded or curved to prevent lacerations or other injuries that could result from impact with a sharp or straight edge

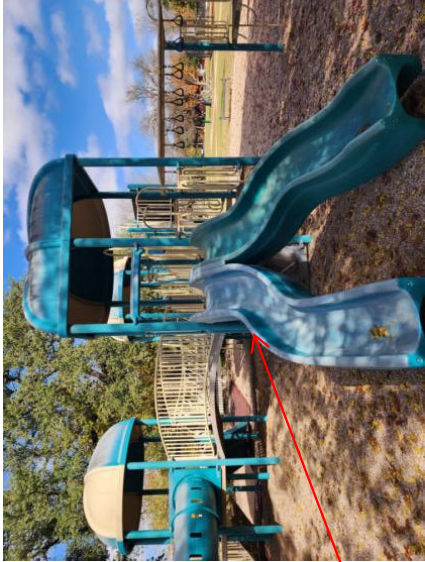
1 (52)

Compliant

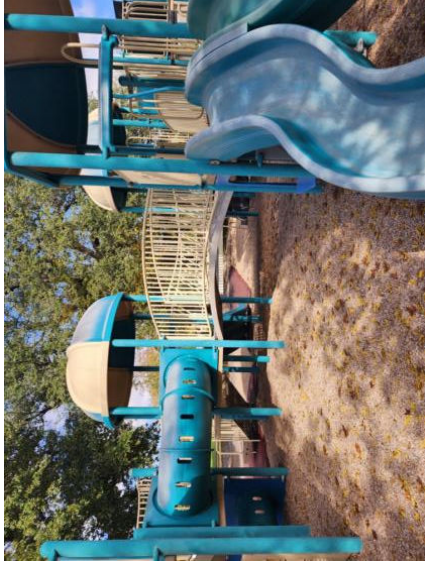
1 (54)

Crawl Tube

Compliant

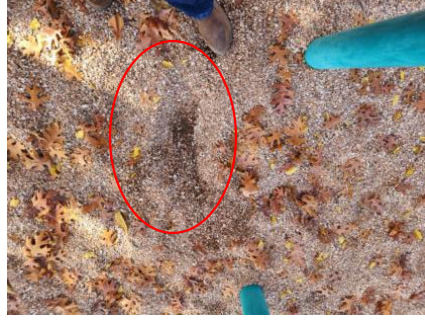
1 (59)

The dark area represents the earth beneath the surfacing.

There is not safety surfacing around the play structure. The years of the pea gravel exposed to rain, wind, dust, dirt, has created a hard surface. The entire area of the use zone will need to be removed and a new surfacing added. Pea gravel has only been tested for a fall height of 60". Is not accessible for users with disabilities.

Deficiency

Replace

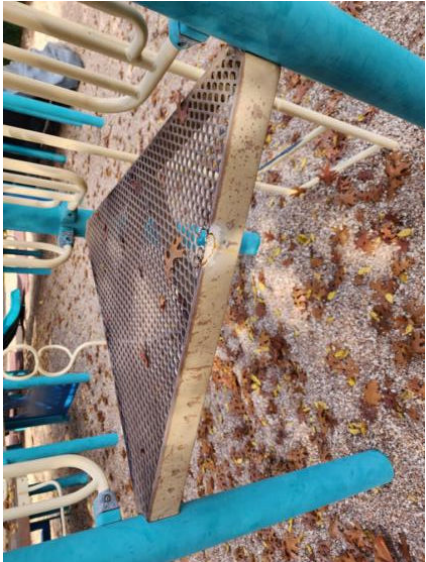
1 (62)

The expanded metal has rusted through.
Repair or replace platform.

Deficiency

Suggest re coating platforms and stairs. The rust may not be presenting structural deficiencies. If that route is done, verify.

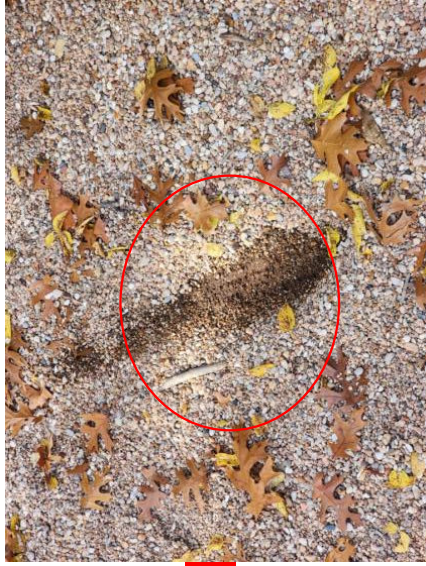
1 (73)

Fail

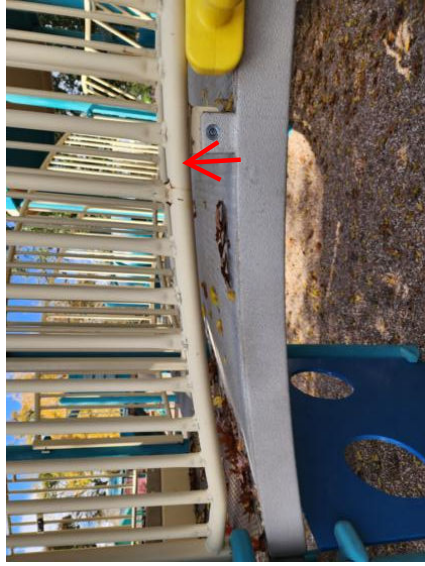
1 (75)

Compliant

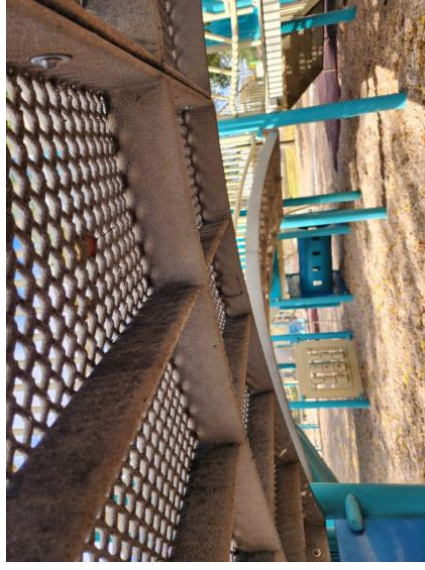
1 (77)

Pass

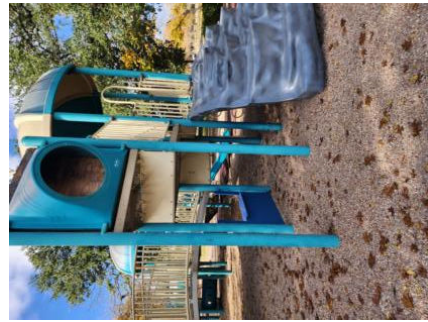
1 (83)

Head entrapment by head-first entry generally occurs when children place their heads through an opening in one orientation, turn their heads to a different orientation, then are unable to get themselves out. Head entrapment by feet first entry involves children who generally sit or lie down and slide their feet into an opening that is large enough to permit their bodies to go through but is not large enough to permit their heads to go through.

Opening 3.5", and less than 9" is considered entrapment

Pass

The yellow probe represents the body of a child, for the 5-12 age group, 5% percentile. (smallest child)

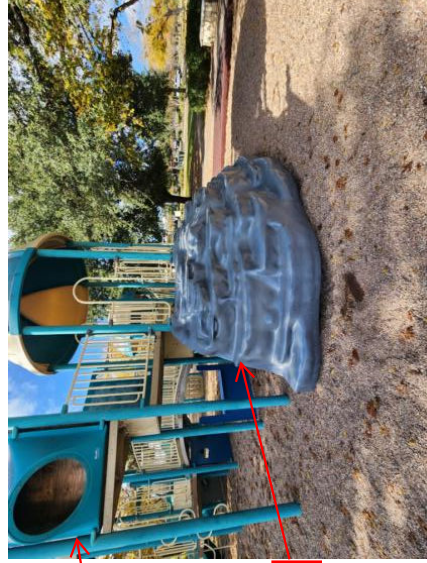
1 (88)

Compliant

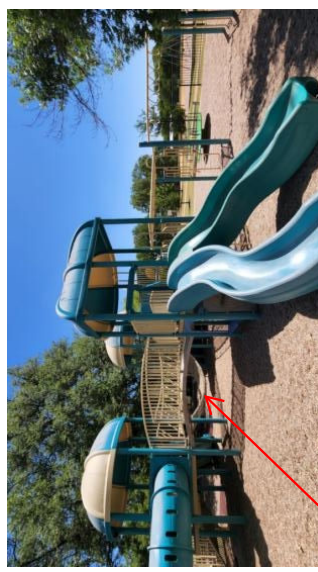
2022, this event was a flexible bridge.

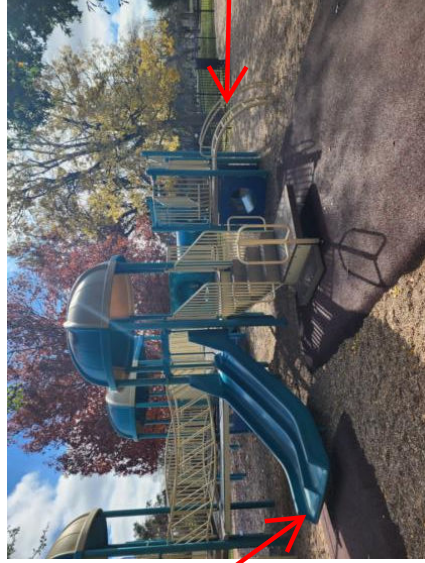
1 (100)

Compliant

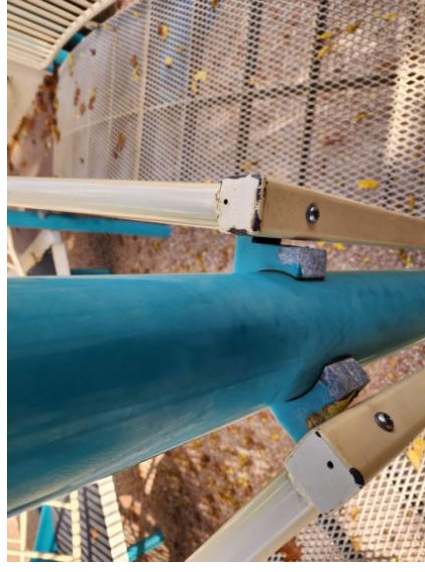
1 (109)

3.3.2 Partially bound openings and angles. Children can become entrapped by partially bound openings, such as those formed by two or more playground parts.

- Angles formed by two accessible adjacent parts should be greater than 55 degrees unless the lowest leg is horizontal or below horizontal.

Pass

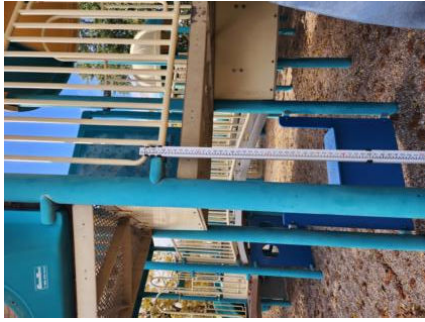
1 (117)

There is not safety surfacing around the play structure. The years of the pea gravel exposed to rain, wind, dust, dirt, has created a hard surface. The entire area of the use zone will need to be removed and a new surfacing added. Pea gravel has only been tested for a fall height of 60". Is not accessible for users with disabilities.

Replace

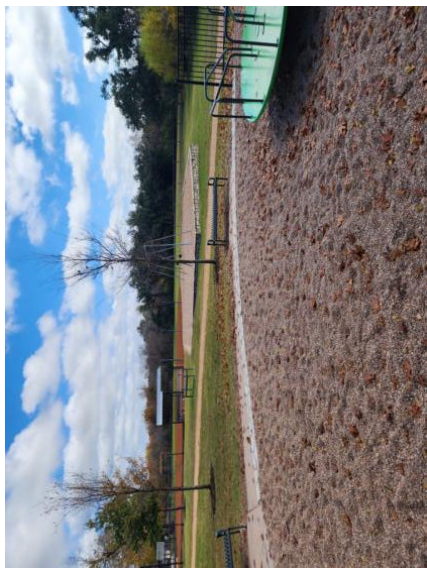
1 (123)

Fall height of the swing

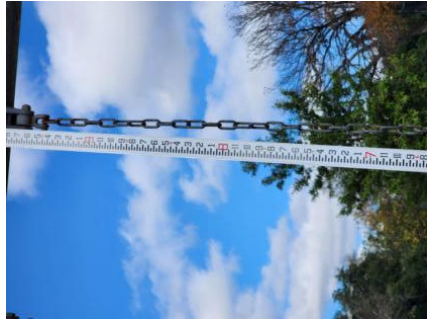
1 (125)

Fall height of the swing

Pea gravel has only been tested
for a fall height of 60".

Fail

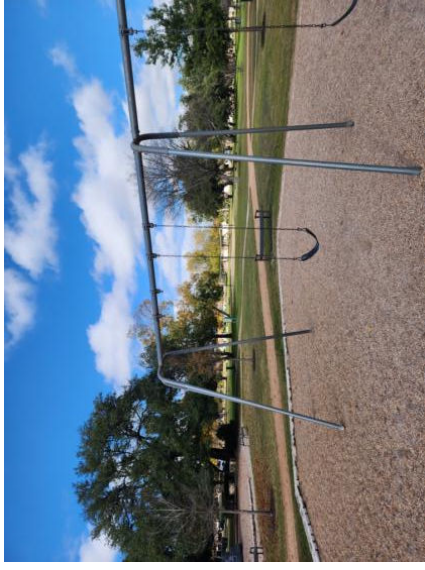
1 (129)

Chain couplings
need to be
adjusted for a
minimum of 20"

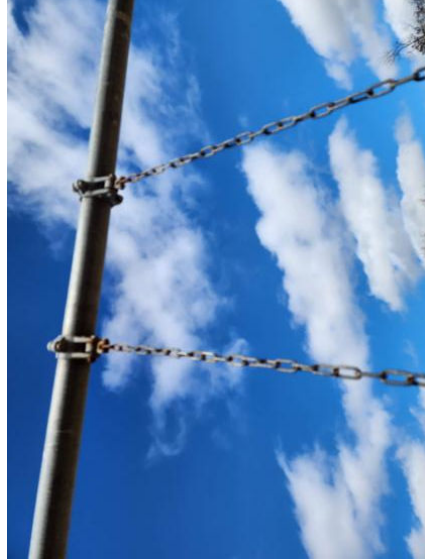
1 (132)

Pea Gravel will not protect from this fall height of 94".
(Photo from 2022, same condition in 2023. Due to the sun brightness, and position, current photo is not viewable.)

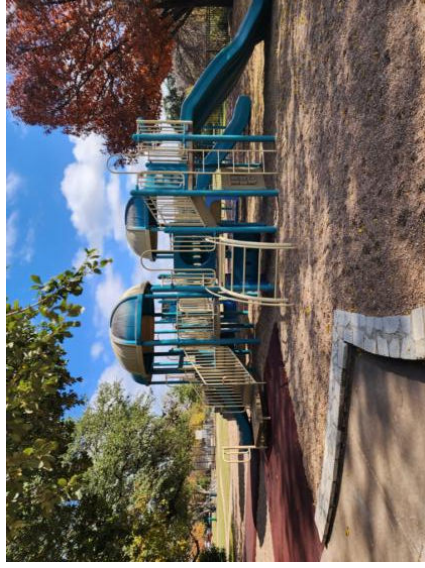
1 (137)

Pass

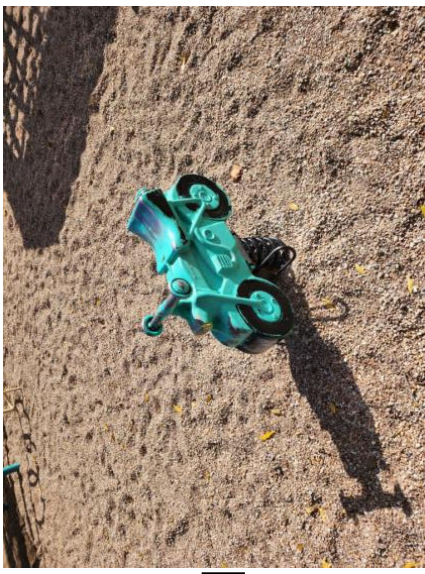
1 (141)

Pass

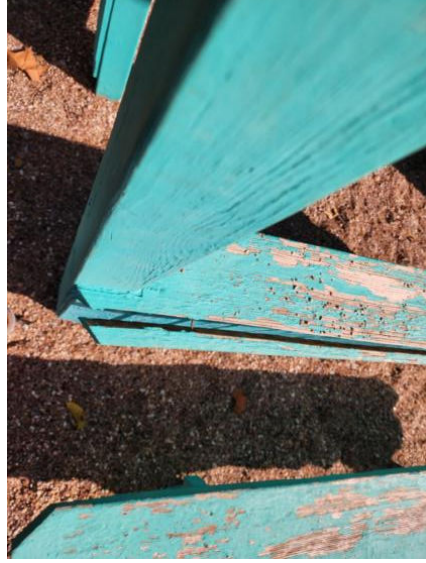
1 (146)

Peeling paint, splinters developing

FAIL
